Lake LeAnn 2023 LFA Evaluation Data, Accumulative Conclusions, and 2024 Management Recommendations Hillsdale County, Michigan

Prepared by: Restorative Lake Sciences
18406 West Spring Lake Road
Spring Lake, Michigan 49456
www.restorativelakesciences.com

Lake LeAnn 2023 Limnological Evaluation Data and 2024 Management Recommendations Hillsdale County, Michigan

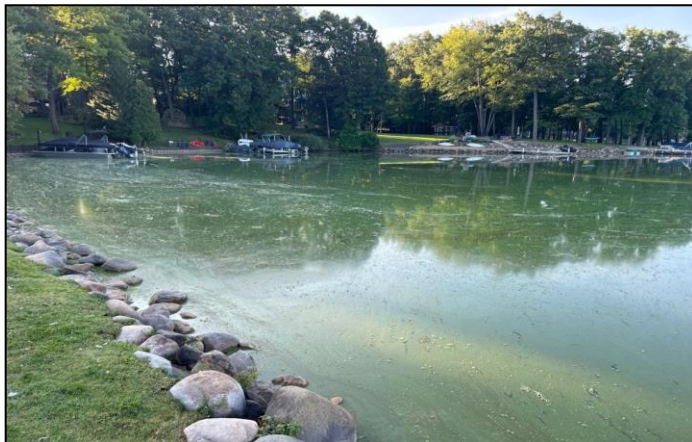
Figure 5. A large-scale blue-green algal bloom on North Lake LeAnn (September, 2023).

Although this data was not contracted in 2023, RLS decided to collect this data given the strong presence of blue-green algae in both basins with blooms present in both lake basins. The algal genera were determined from a 500-ml composite water sample collected over the 9 deep basins of Lake LeAnn on September 19, 2023. Sub-samples were collected from the 500-ml sample and placed in a Sedgewick Rafter counting chamber for analysis under a Zeiss® compound bright field microscope. Tables 17 and 18 below show the algal taxa present in the samples collected.

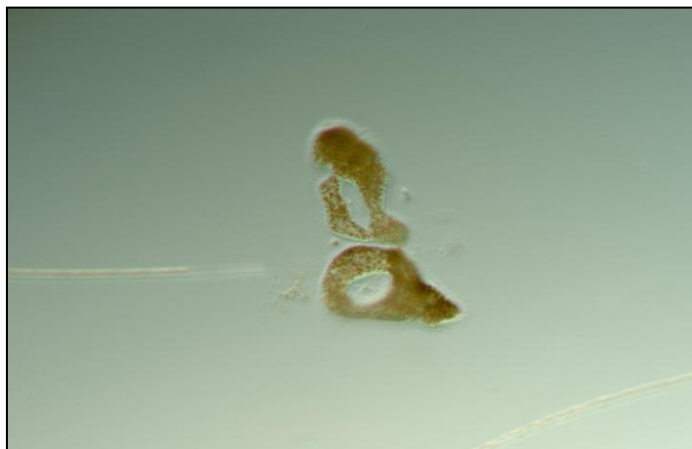
Figure 6. *Microcystis*, a blue-green algae found in both lake basins (RLS, 2023).

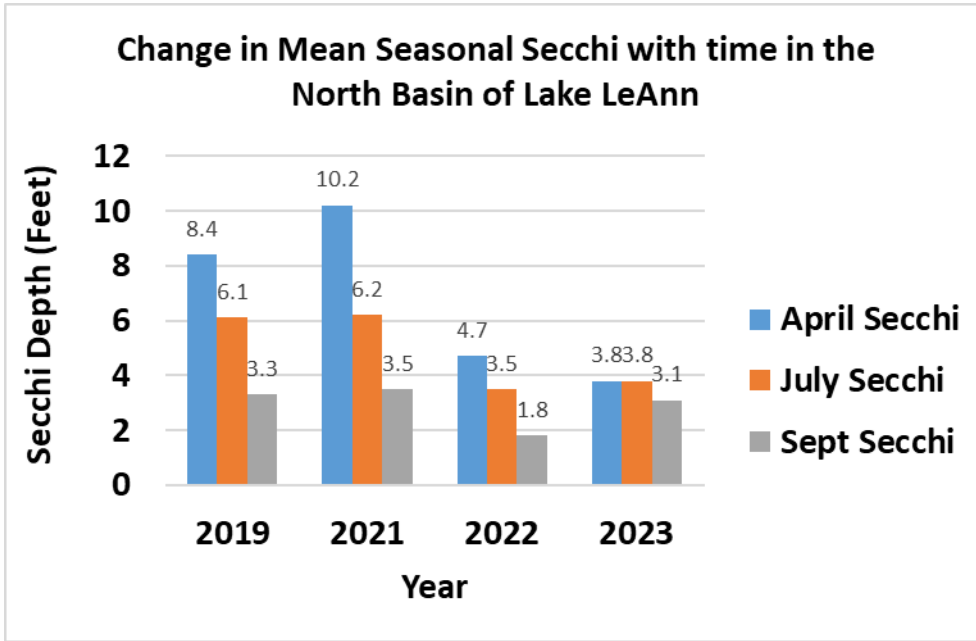
Figure 17. Change in mean seasonal Secchi with Time in the North Basin of Lake LeAnn.

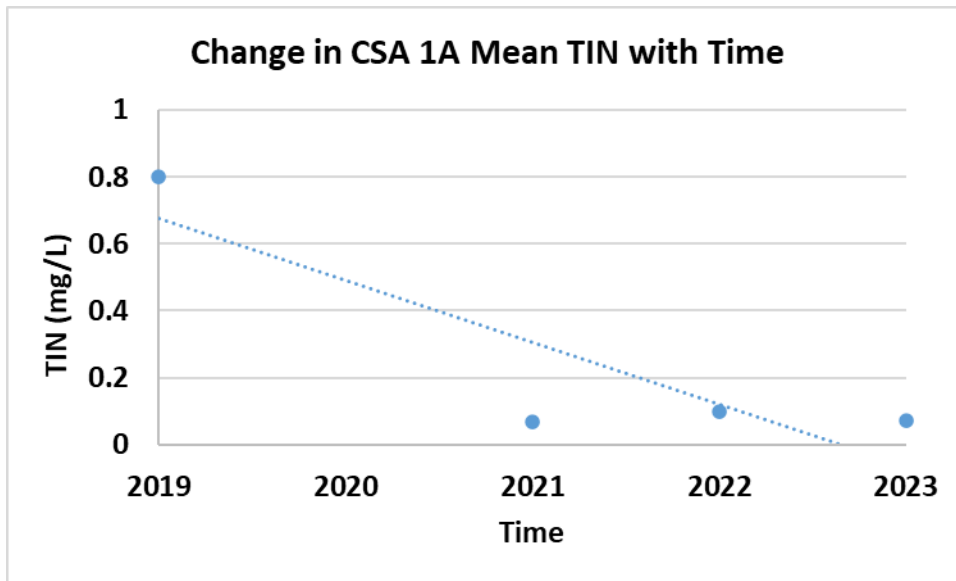
Figure 24. Change in CSA 1A mean TIN with time (2019-2023).

CSA 1A has demonstrated a strong decrease in TP and TIN with time (Figures 23-24). CSA 2A has demonstrated an increase in TP in 2023 and an increase in 2022 with a decline to historic levels in 2023 (Figures 25-26). Continued mitigation of these CSA drains is recommended with biochar to remove the nutrients and decrease both TP and TIN. Recent mitigation efforts in 2A and 2B have resulted in reduction of solids in both drains with less transport to the lake basin.
